# Salvinia best practice management

# Current best practice

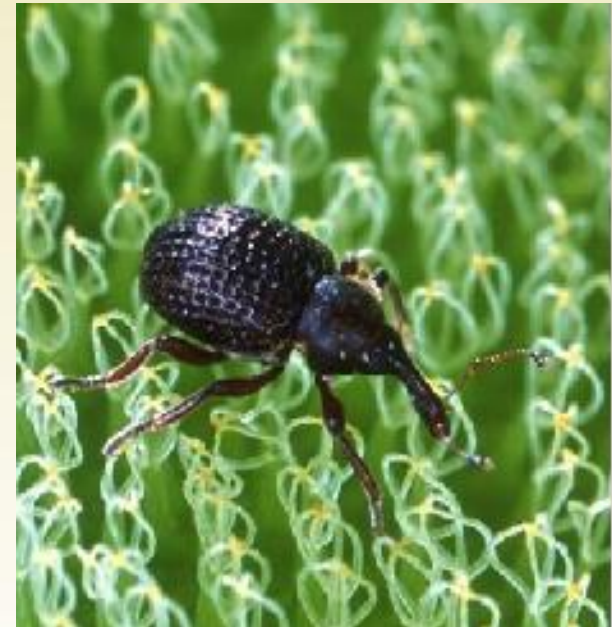
early in 14<sup>th</sup>  
month

Effective biocontrol over  
14 months in subtropics

middle of 14<sup>th</sup>  
month

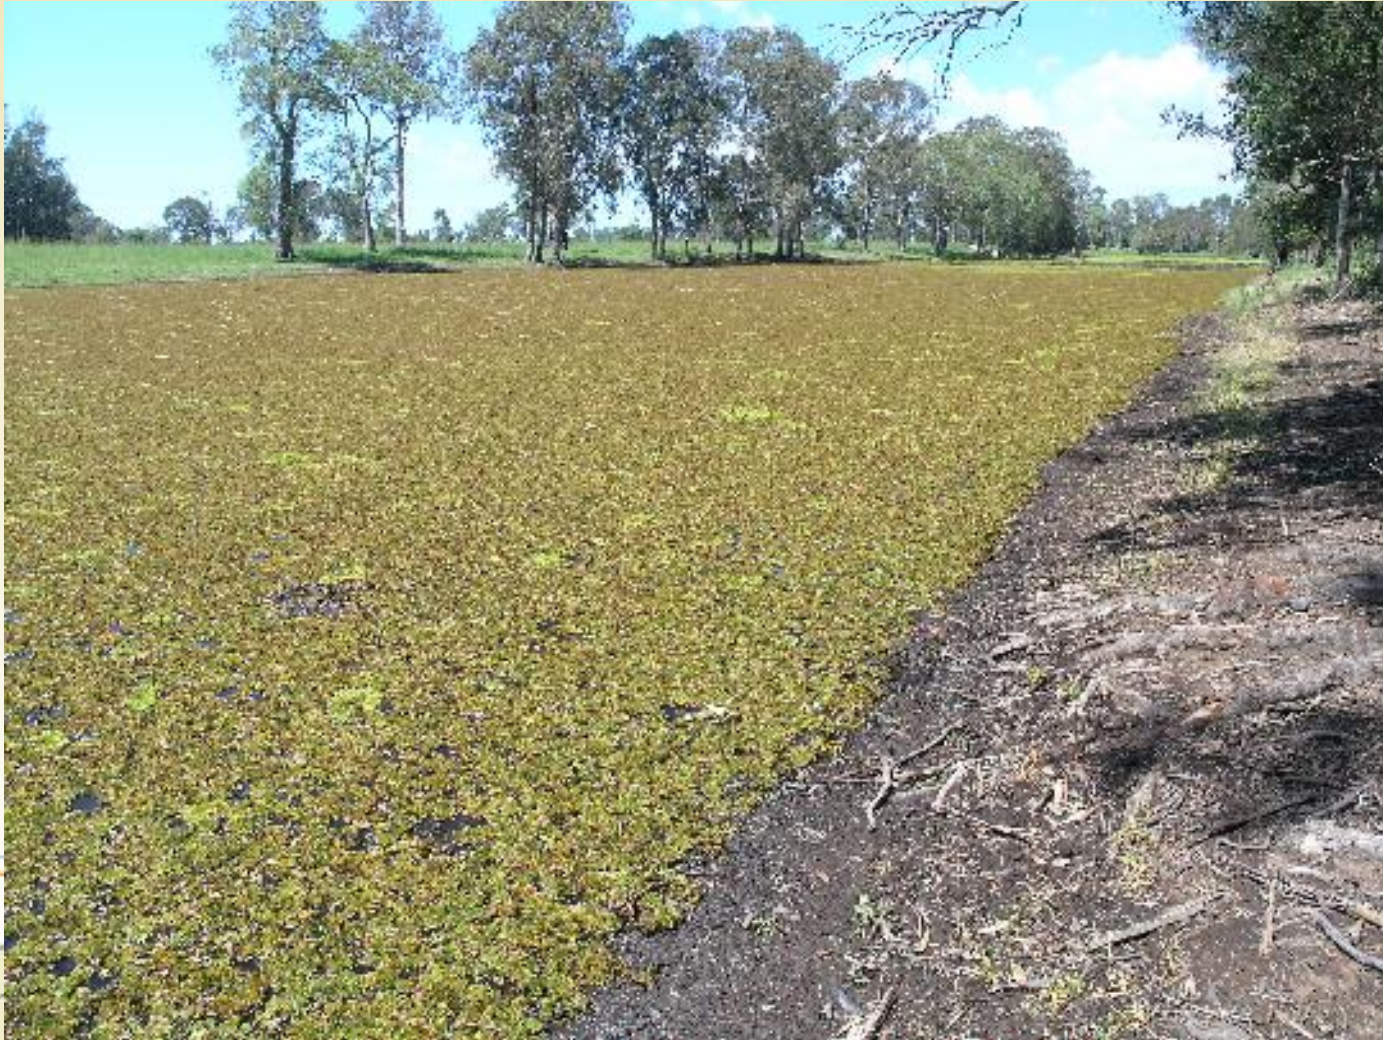
# regrowth after 1<sup>st</sup> glyphosate

- effective on single-layered infestations
- needs up to three applications
- has no label registration, can only be used under permit

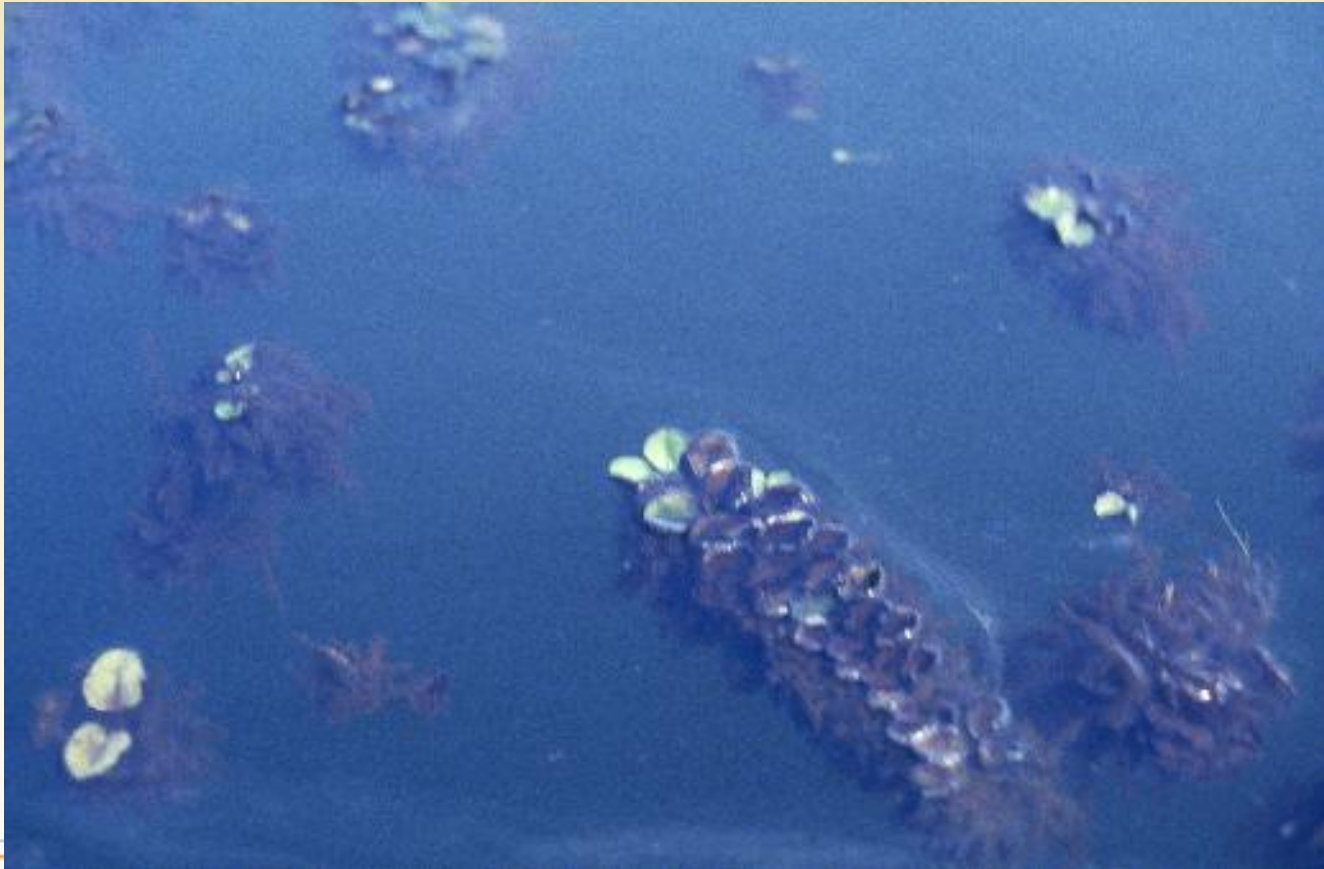
# Regrowth after Immerse herbicide

- effective on primary form and scattered plants
- very good as follow up
- approved for use in protected areas (kero component not tested and is cause for concern)

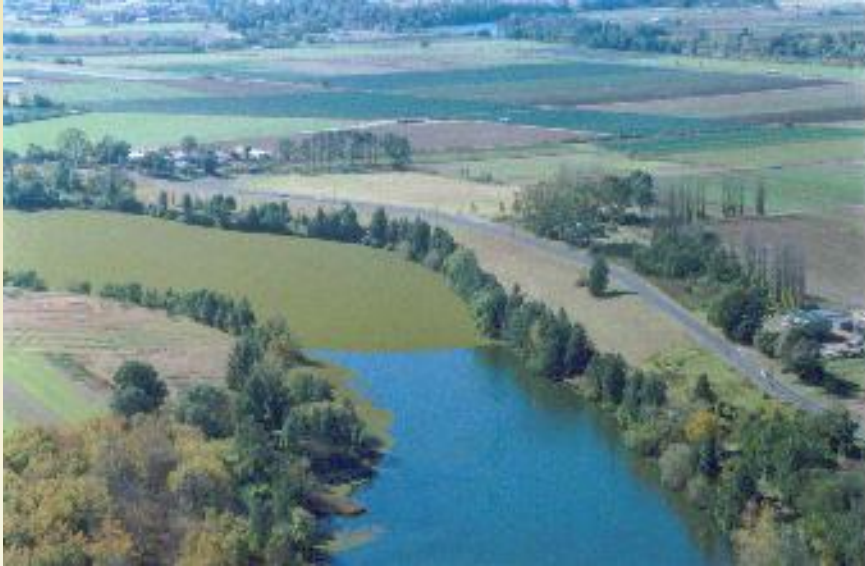
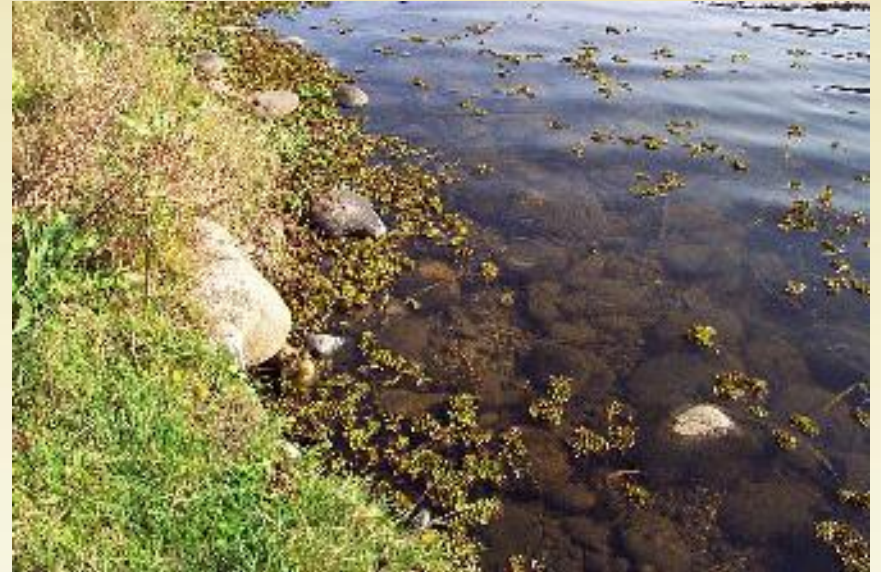
# Hawkesbury River

- 88 kms river and tribs. covered in tertiary salvinia
- team of harvesters worked non-stop for 8 months
- estimated 140 000 t salvinia removed over 14 months
- ongoing management occurring (biocontrol, spot spraying, booms).

- broad scale often cost prohibitive, certain situations call for it - Hawkesbury River is example of extreme costs and effort once an infestation has become so extensive
- ongoing small scale is BP - Ewen Maddock Dam is example of best practice salvinia management (in house mechanical scoop)
- manual removal very useful for follow up/eradication efforts - Myall Lakes National Park is example of eradication potential using extensive manual removal

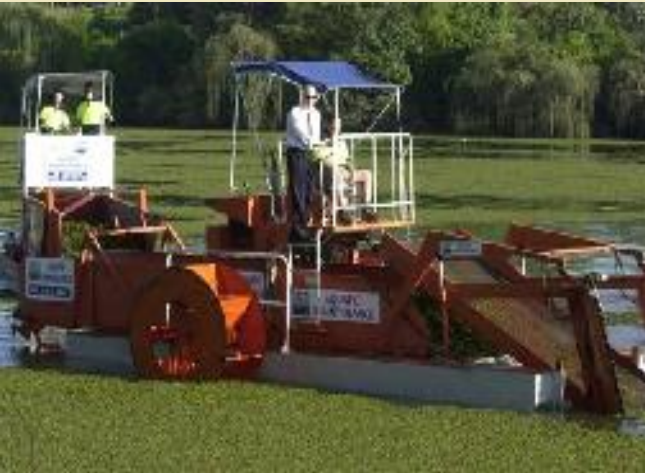
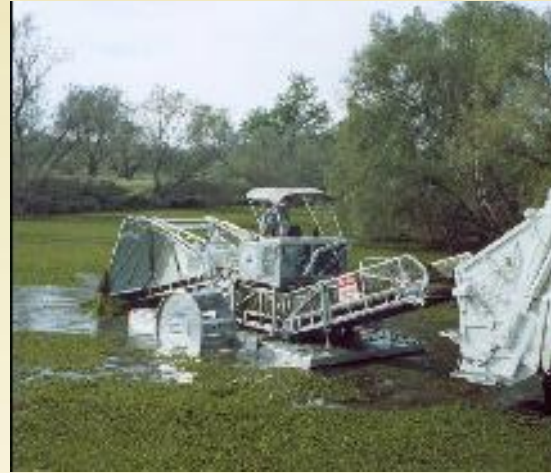
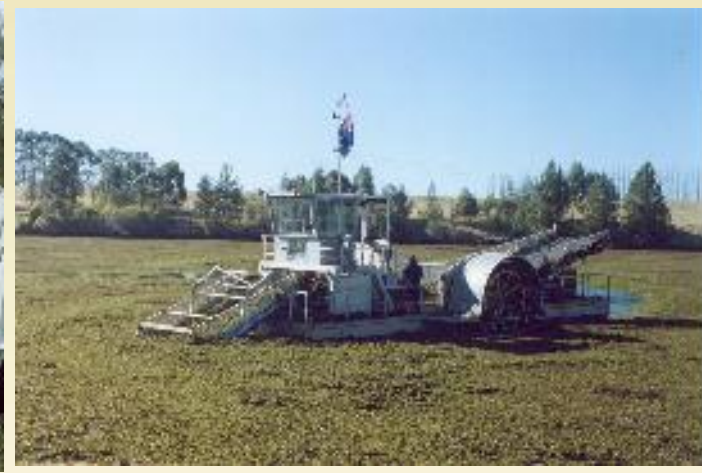
# Commercial harvesters

Two 13-m<sup>3</sup> capacity harvesters (cost between \$1000 and \$1800 per day)

One 26-m<sup>3</sup> capacity harvester (worked at cost for three months, \$12 300 per 6 day week inc. deck hand)

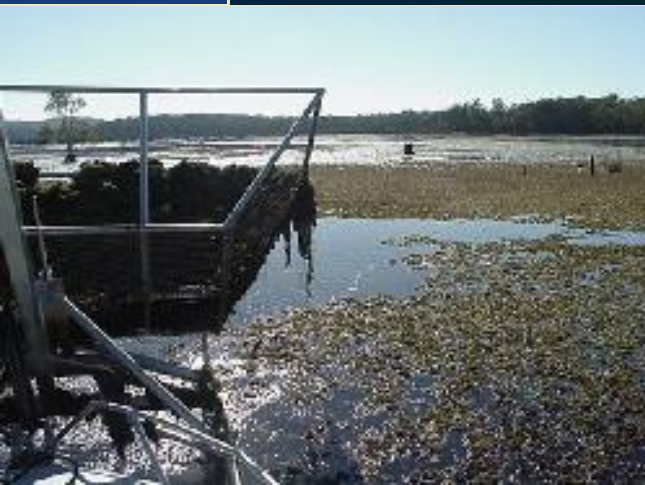
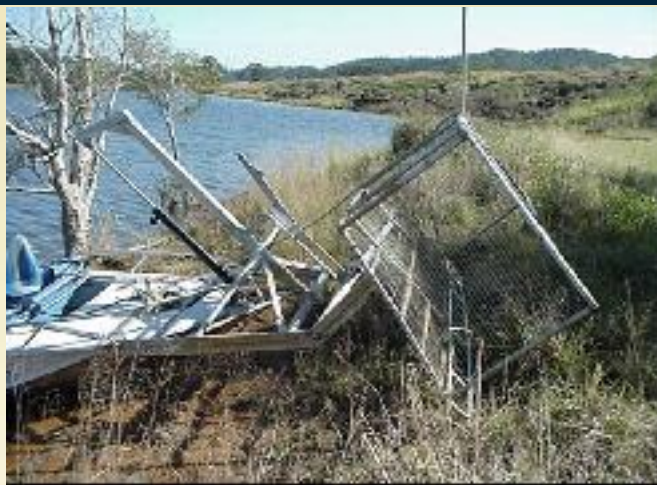
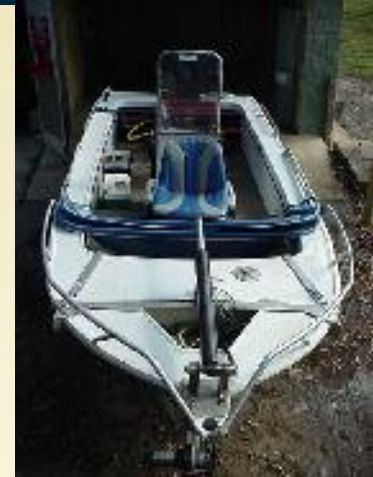
# Ewen Maddock Dam

- boat and scoop cost between \$5000 and \$7000, plus fuel (\$2080 in 2005) plus operator (\$2220 in 2005 – 74 hrs).
- herbicide sprayed on dumped and stranded salvinia
- booms and biocontrol also used

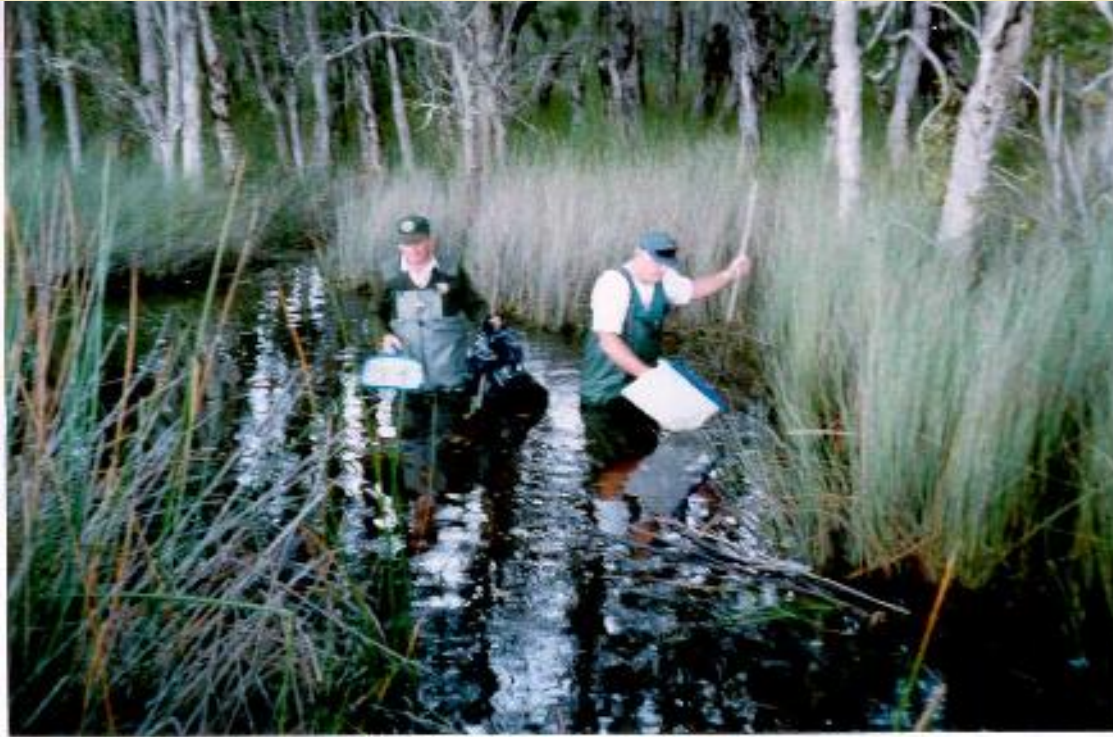
# Manual removal – Myall Lakes

- successful eradication, half tonne salvinia manually removed along 15km of shore line.

- initial bulk removed by 20 staff, 2 weeks, 2 km of creek line, using pool scoops and 20L garbage bins or bags
- 4 staff over 80 days in body of lake
- follow up was 4 people over 30 days across a 2 year period.

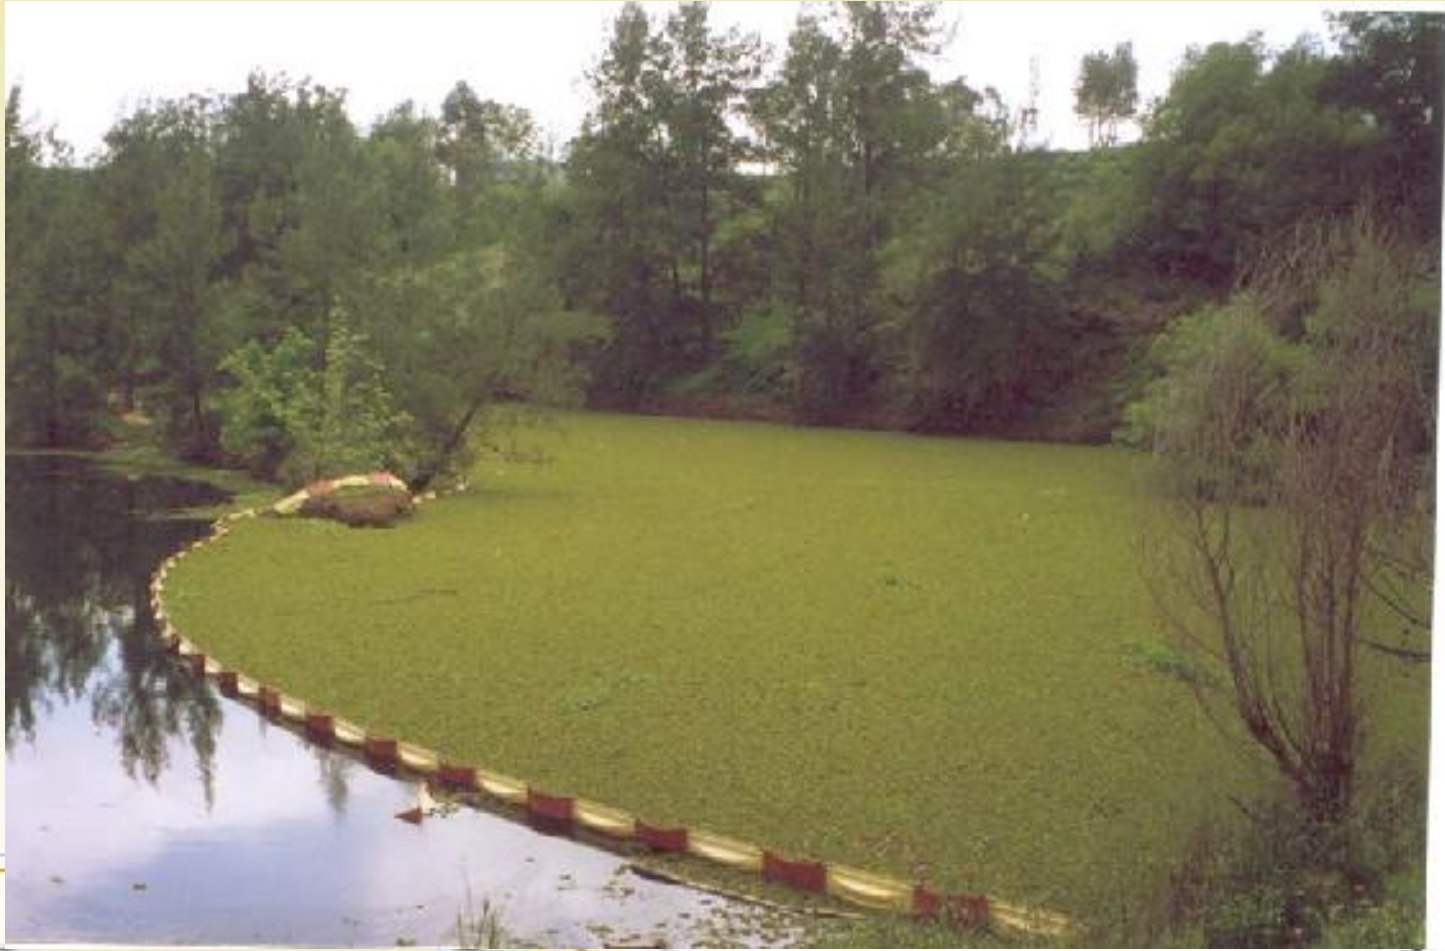
# Booms and containment

- Each control method has a best practice role (biocontrol, physical removal, herbicides).
- Booms are an essential management tool.
- Need for ongoing management
  - follow up always required, eradication is rare, salvinia will always be present.
